Bee Line Consulting and Electric

Date: 06-16-21 Client: MHS Legacy Group Operation: CI Metal Fabrication Project: Picklex 20 Paint Testing Location: Meridian MS

Purpose of Testing ; To check PPG Amerilock 400/2 Air Dry Epoxy adhesion to Picklex 20 Pretreatment applied to 10guage sheet steel and .250 plate 4 Samples

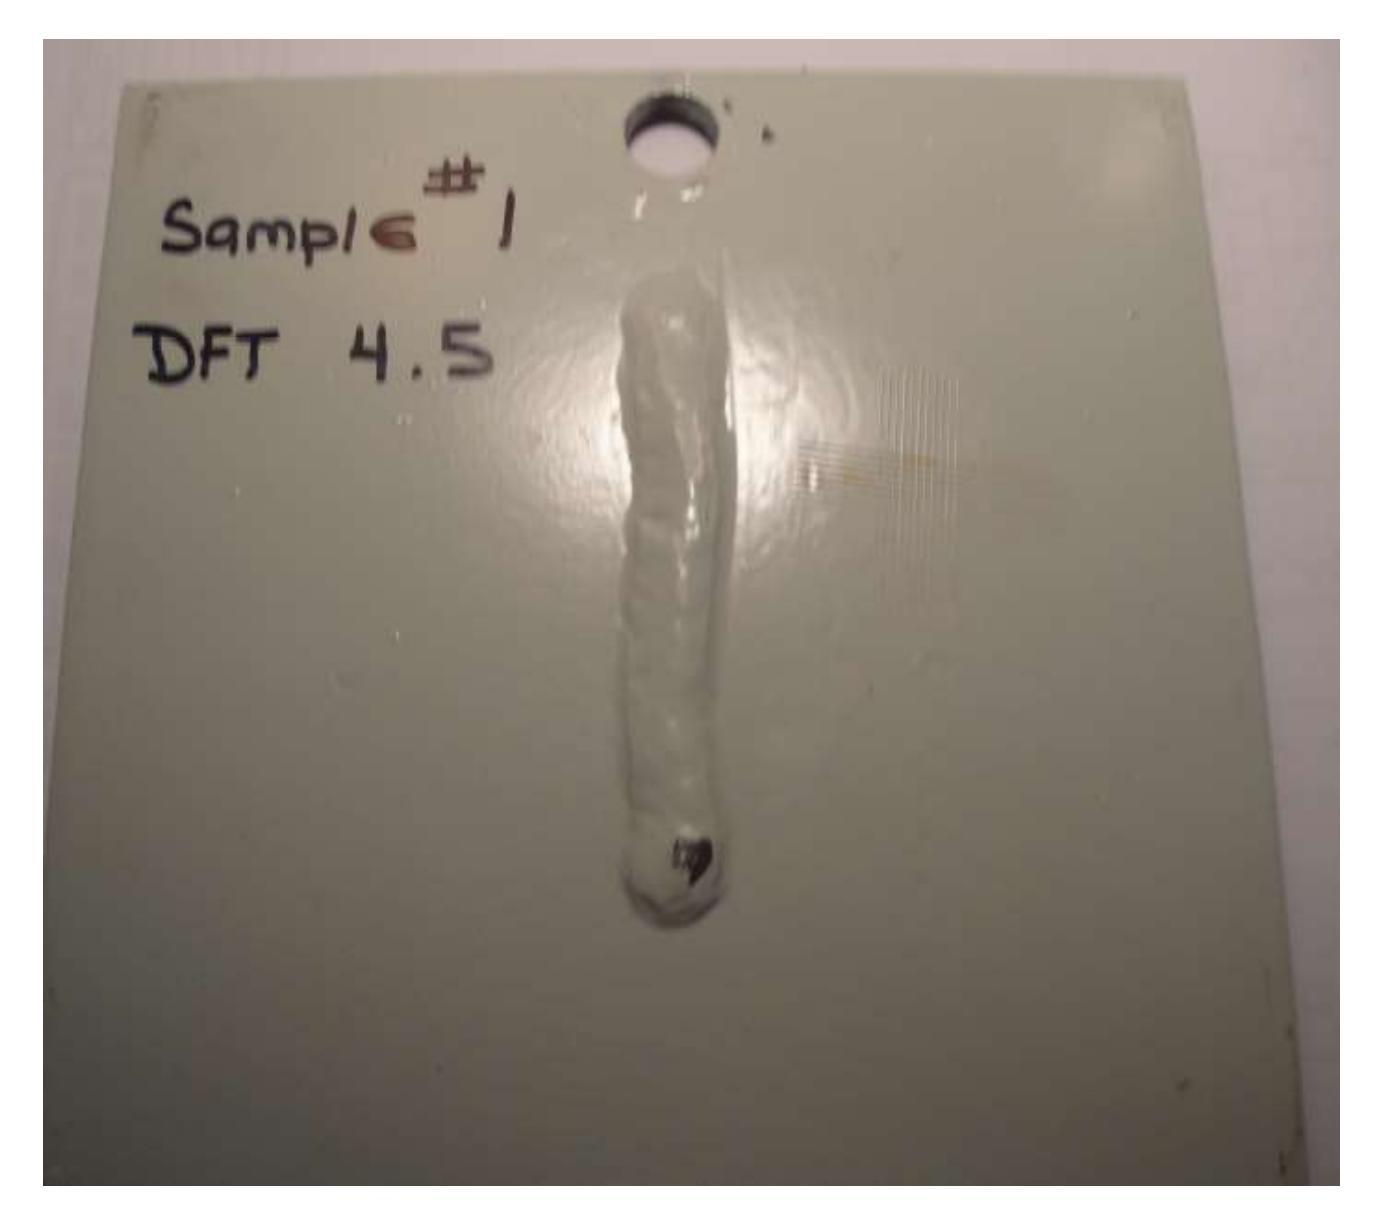
Sample 1 .250 after Solvent test and dry cross hatch Tape pass Chipping is from shipping and handling

Test A : Coating Cure Solvent Rub	Pass	
Test B: Dry Film Thickness	Pass	
Test C: Dry Cross Hatch Adhesion	Pass	
Test D: Boiling Water Cross Hatch Adhesion	Pass	
Test E: Boiling Water Cross Hatch Adhesion	Extended	Pass
Test F: Salt Spray ASTM 1000 hr	Pass

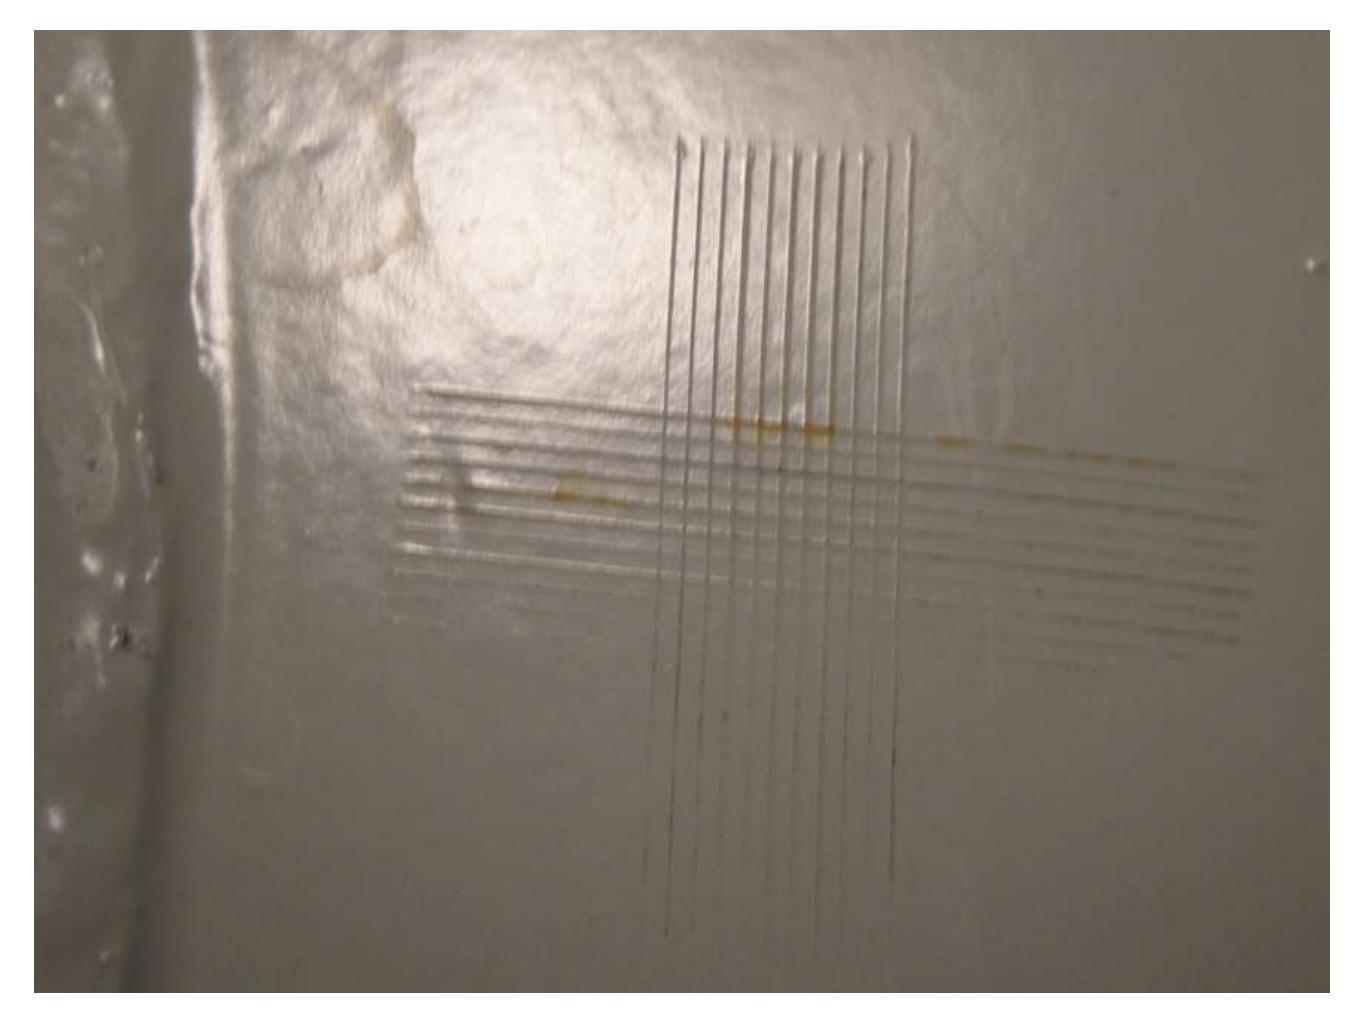
Sample #1 .250 after boiling water cross hatch tape - Pass A thru F

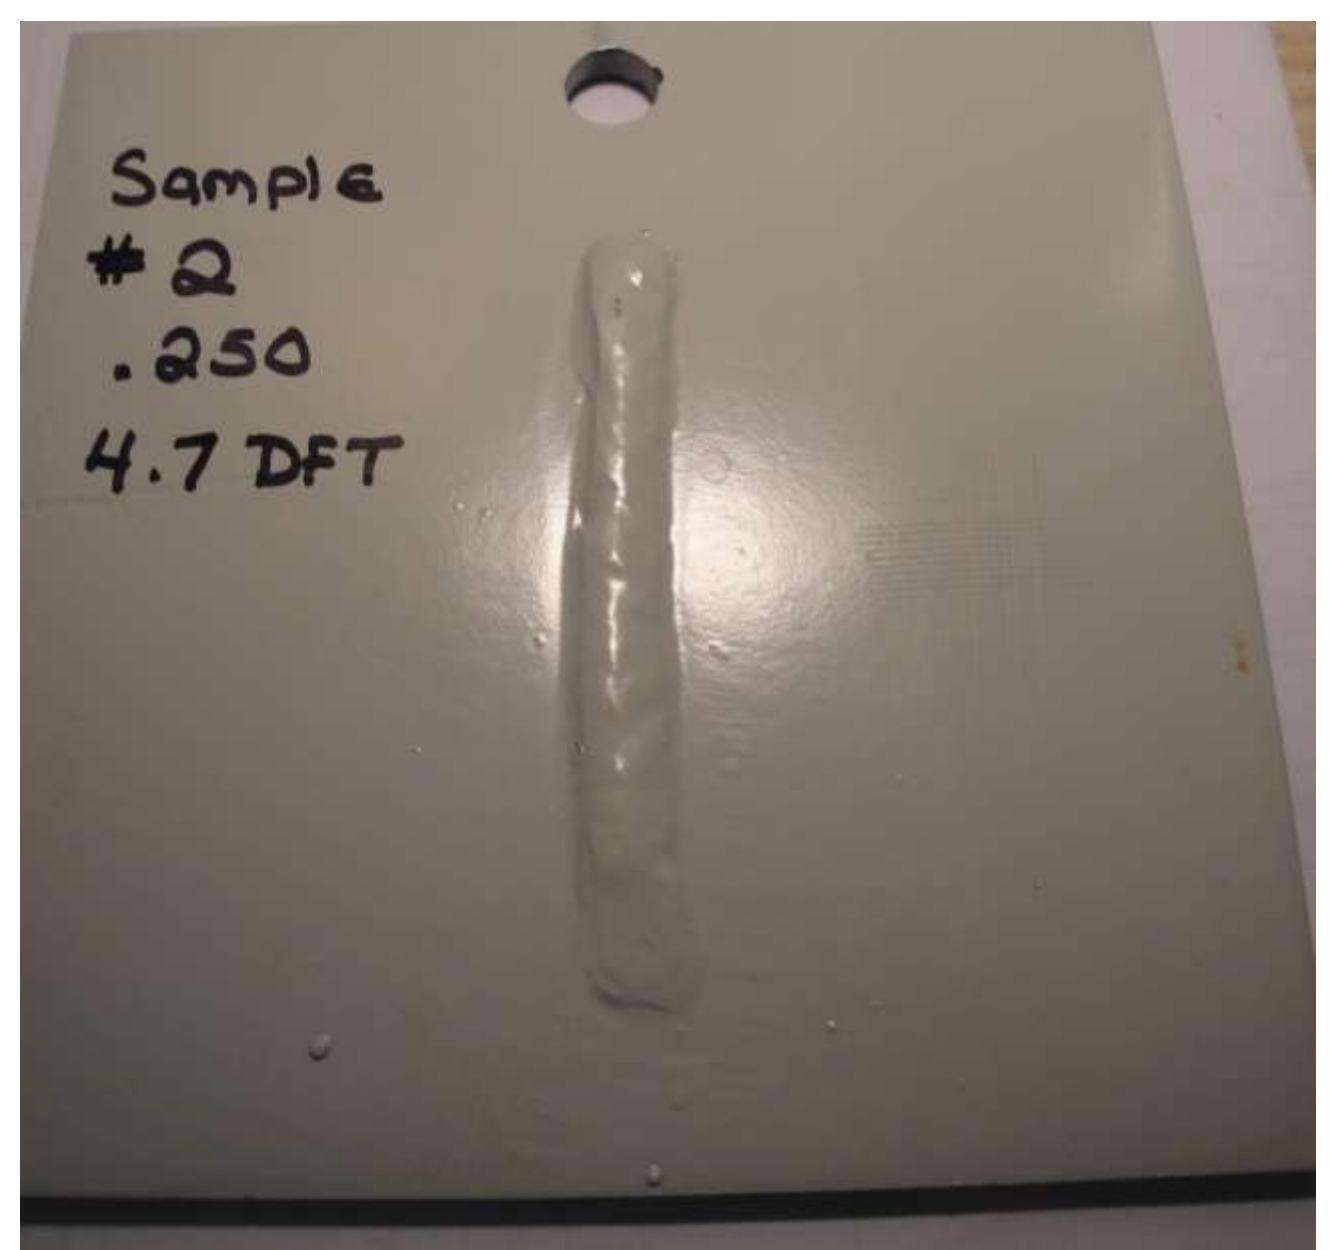
Sample #2.250 after Solvent test and dry cross hatch tape pass

Test A	: Coating Cure Solvent Rub	Pass	
Test B	: Dry Film Thickness	Pass	
Test C	: Dry Cross Hatch Adhesion	Pass	
Test D	: Boiling Water Cross Hatch Adhesion	Pass	20min

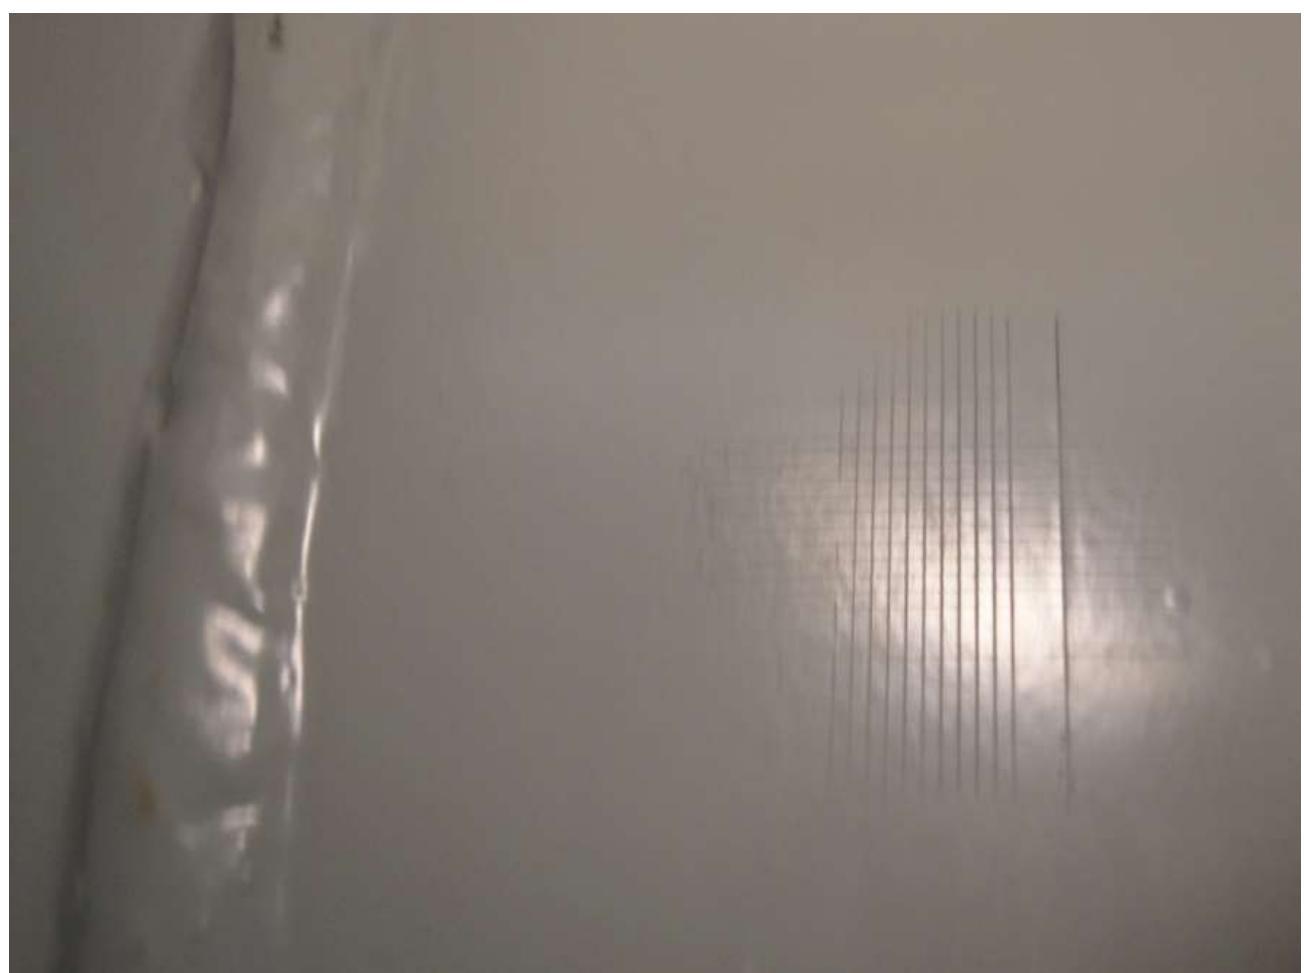
Sample #2 After Boiling Water Cross Hatch Tape Pass

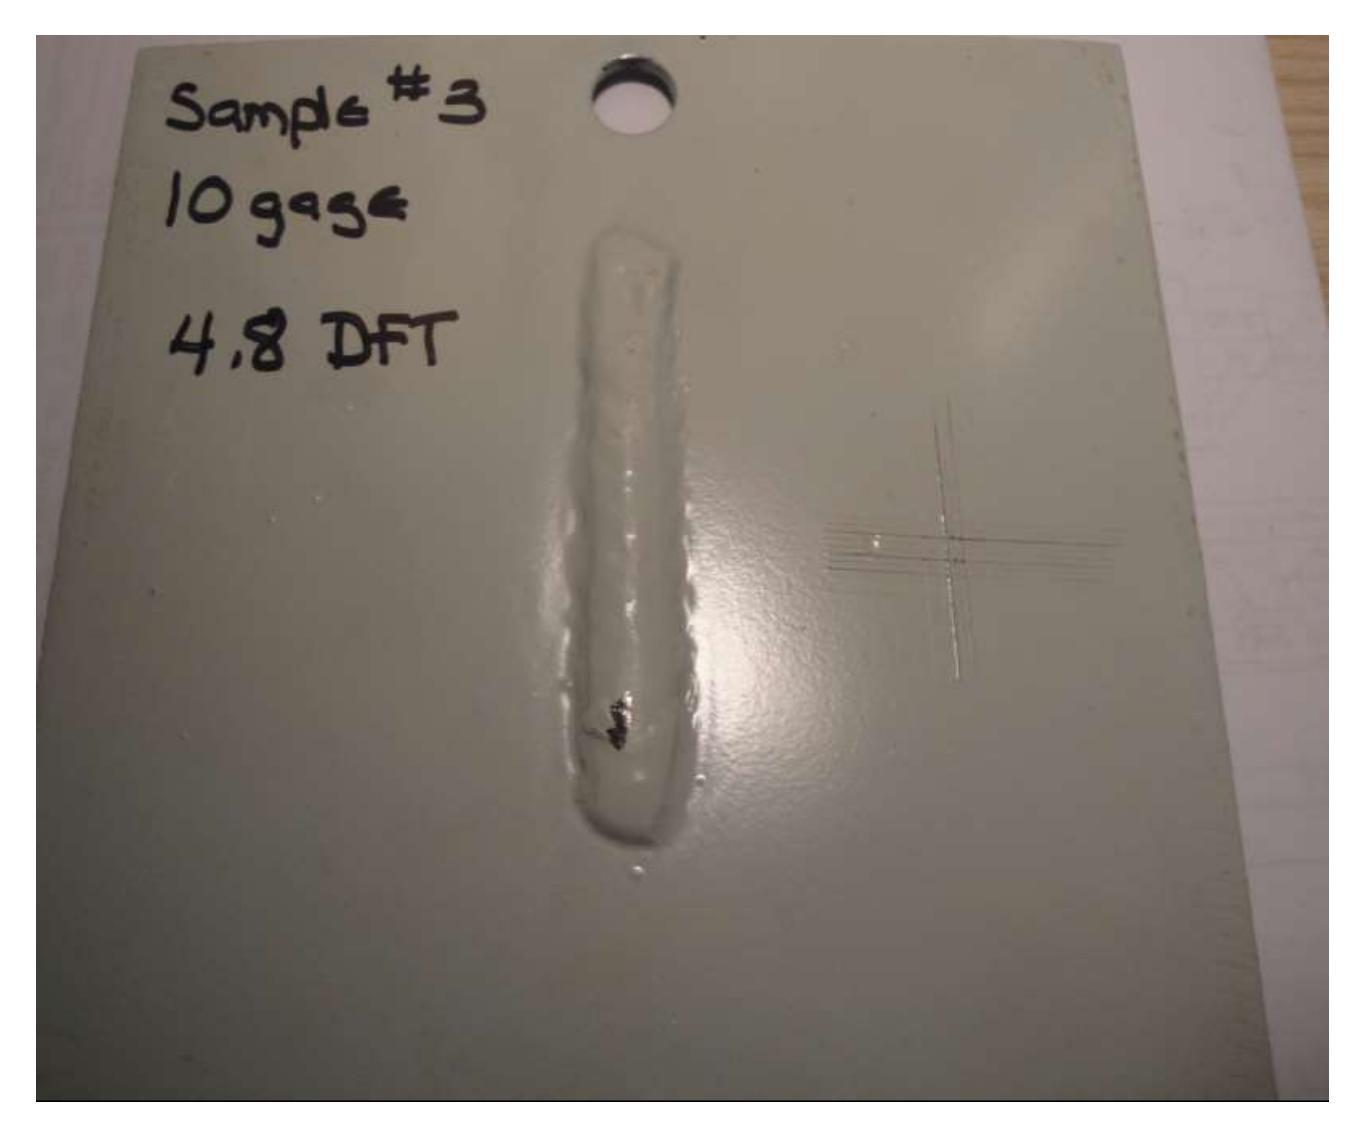
Sample # 3 10 gauge after Solvent test and dry cross hatch tape pass Pass A thru F

Test A : Coating Cure Solvent Rub	Pass	
Test B: Dry Film Thickness	Pass	
Test C: Dry Cross Hatch Adhesion	Pass	
Test D: Boiling Water Cross Hatch Adhesion	Pass	
Test E: Boiling Water Cross Hatch Adhesion	Extended	Pass
Test F: Salt Spray ASTM 1000 hr	Pass

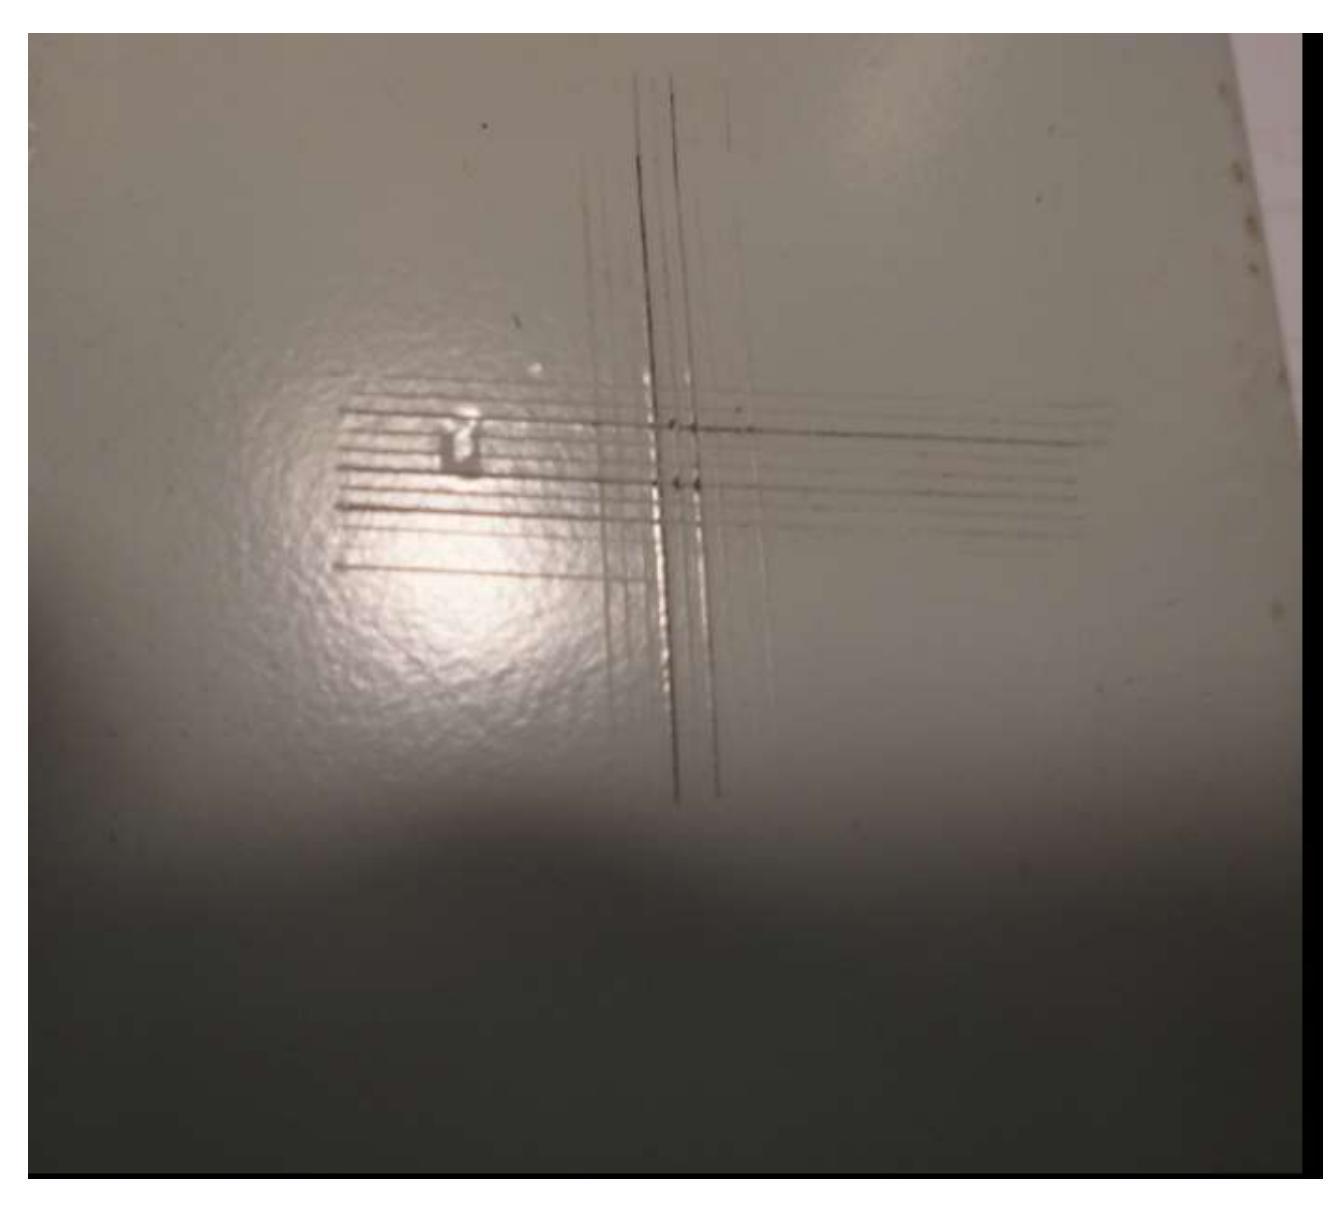
Sample # 3 After Boiling Water Cross Hatch Tape Pass (Chipping at edge due to blade)

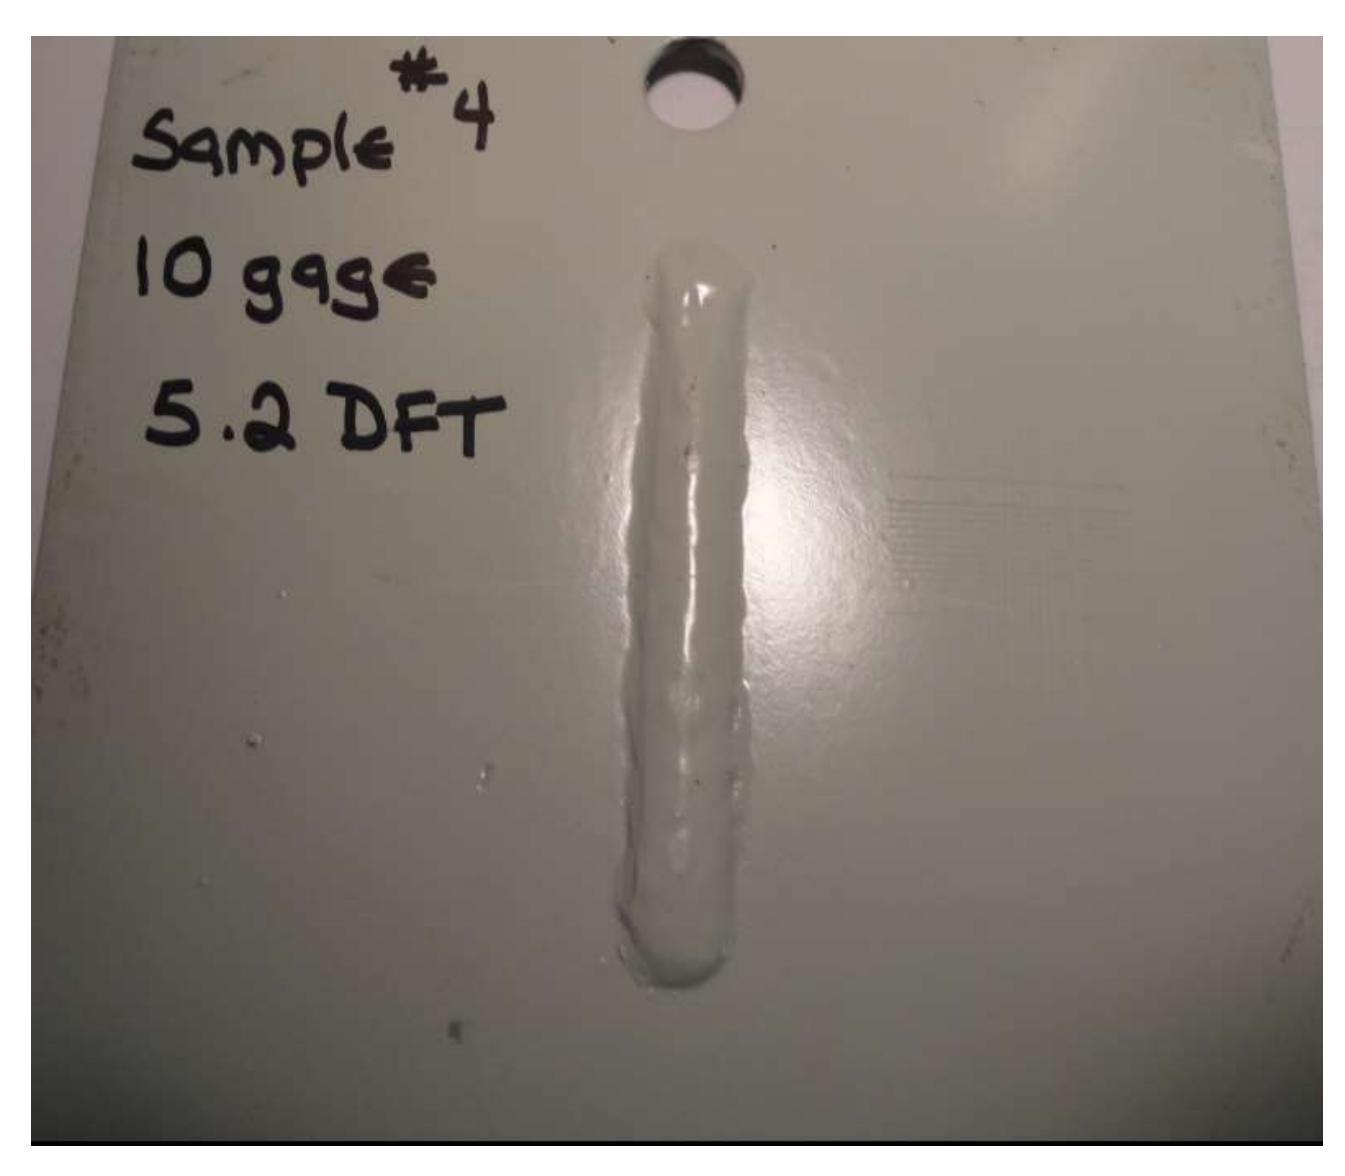
Sample # 4 10 gauge after Solvent test and dry cross hatch tape pass

Test A : Coating Cure Solvent Rub	Pass
Test B: Dry Film Thickness	Pass
Test C: Dry Cross Hatch Adhesion	Pass
Test D: Boiling Water Cross Hatch Adhesion	Pass
