NASF SURFACE TECHNOLOGY WHITE PAPERS
81 (4), 15-27 (January 2017)

3rd Quarterly Report
July-September 2016
AESF Research Project #R-118

Crack Formation during Electrodeposition and
Post-deposition Aging of Thin Film Coatings

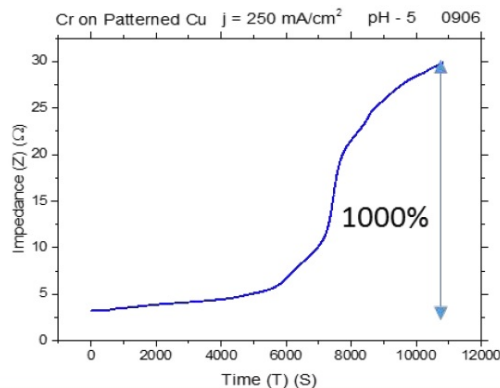
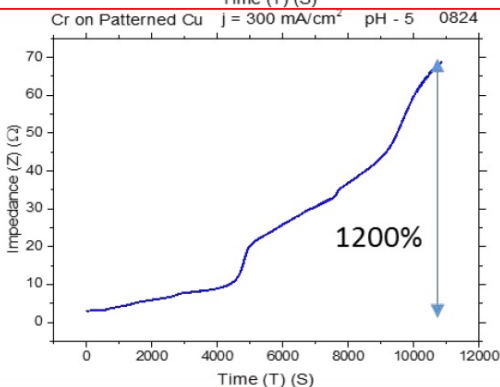
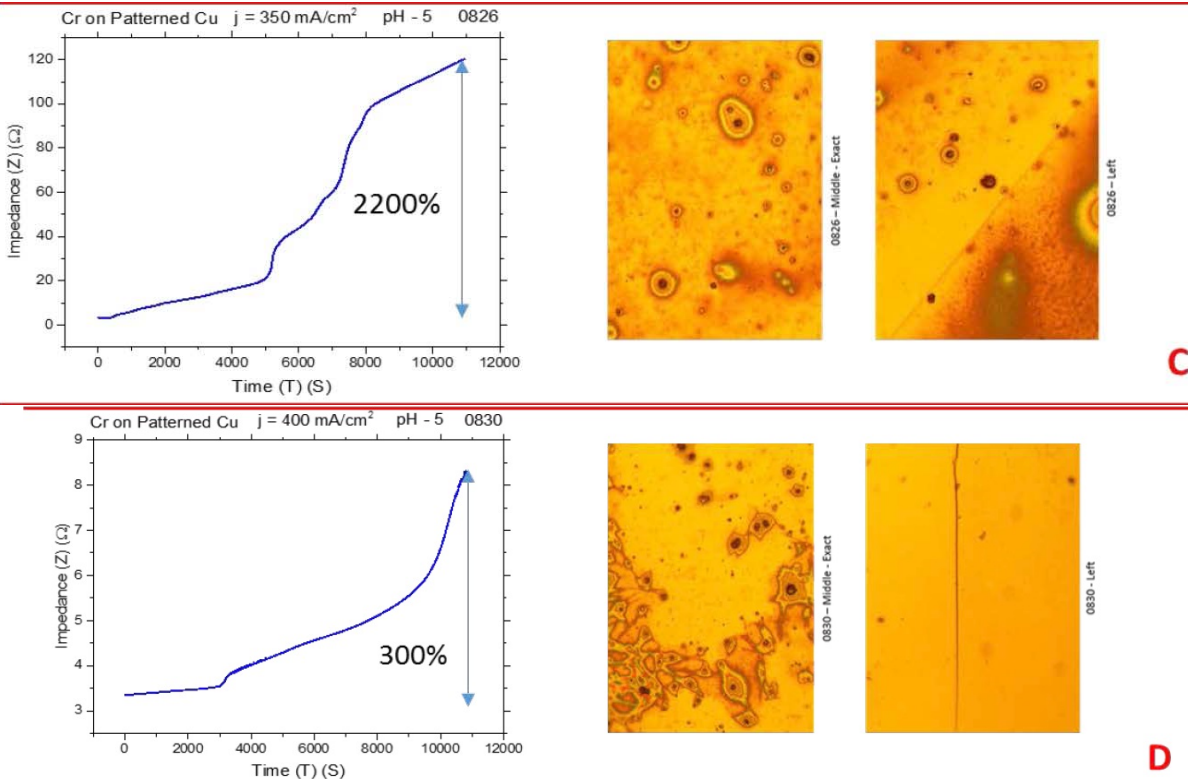
Figure 1 - *In situ* impedance measurements of chromium films during aging at room temperature in air: chromium films deposited for ~3 hr at (a) 250 mA/cm², (b) 300 mA/cm², (c) 350 mA/cm² and (d) 400 mA/cm². Optical images are taken from the center and very near edge of the sample; AC amplitude 3 mV, frequency 50 kHz.

The observed resistance changes for chromium films deposited with different current densities are shown in Fig. 1(a-d), over pages 16 and 17. The optical images of the representative morphology of the chromium surface for each sample are also shown on the right side for each transient. Impedance transients were recorded over the time intervals of 3 hr, while the approximate chromium film thickness was around 15 microns. The maximum change in the impedance value is indicated in the graph.

The common feature of all results in Fig. 1 is the quite significant magnitude of the impedance change. It ranges from 300% to 2200%. There is no obvious trend and correlation of the impedance change with respect to the conditions of the electrodeposition process and deposition current density. Initially, (Fig. 1(a-c), Fig. 2) we see the increasing impedance change with increasing current density, ($j = 250\text{-}350\text{ mA/cm}^2$) and then, a significant decrease in relative change of impedance with further increase of current density, Fig. 1(d), and Fig. 2.

The optical inspection of the chromium samples as well as the smooth appearance of the impedance transients do indicate that no crack formation in the chromium deposited films occurs at room temperature as a result of the aging process. This is a bit surprising considering the large values of impedance change that are observed. Indirectly the data suggests that the source of such a huge change of the impedance of chromium films must be related to the increased volume concentration of the defects in the chromium films.

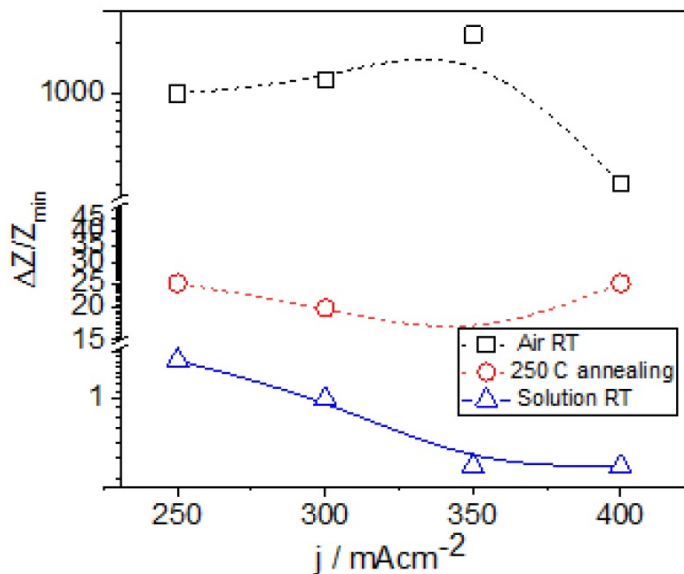
Figure 2 - Relative change of the impedance of ~15 μm chromium films during the aging process in Cr-formate solution and in air at different temperatures. Black - room temperature data from Fig. 1 (copper seed); Blue - room temperature data recorded during aging in solution (copper seed, Report #2; <http://short.pfonline.com/NASF16Dec2>); Red - 250°C data from Fig. 5, NiCr seed.

The important thing to notice here is a different magnitude of the impedance change for two different aging processes at room temperature. In the case of the aging of chromium films in Cr-formate solution, the change of the impedance was of the order of 1% (Fig. 2). The aging process in air, at the same temperature results in almost three orders of magnitude larger impedance change. The observed trends with respect to the current density used for sample preparation also diverge. In reality, the aging in air is the more relevant process to consider since it is to happen no matter what the application of the chromium coating might be. Yet, the huge difference in results seems to be only related to the environment (solution vs. air).

The observed trend in relative impedance change as a function of the current density used for chromium deposition is quite different than the one obtained from room temperature measurements, Fig. 2. It is almost the opposite of the one observed for samples aged in air and, surprisingly, more similar to the one for samples aged in solution. The relative change of the impedance is about an order of magnitude larger than that from the samples aged in solution, and about two orders of magnitude lower than the one from the samples aged in air, Fig. 2. To some extent this is unexpected as one would anticipate that cracking of the chromium films should result in a very large increase of the chromium thin film impedance.

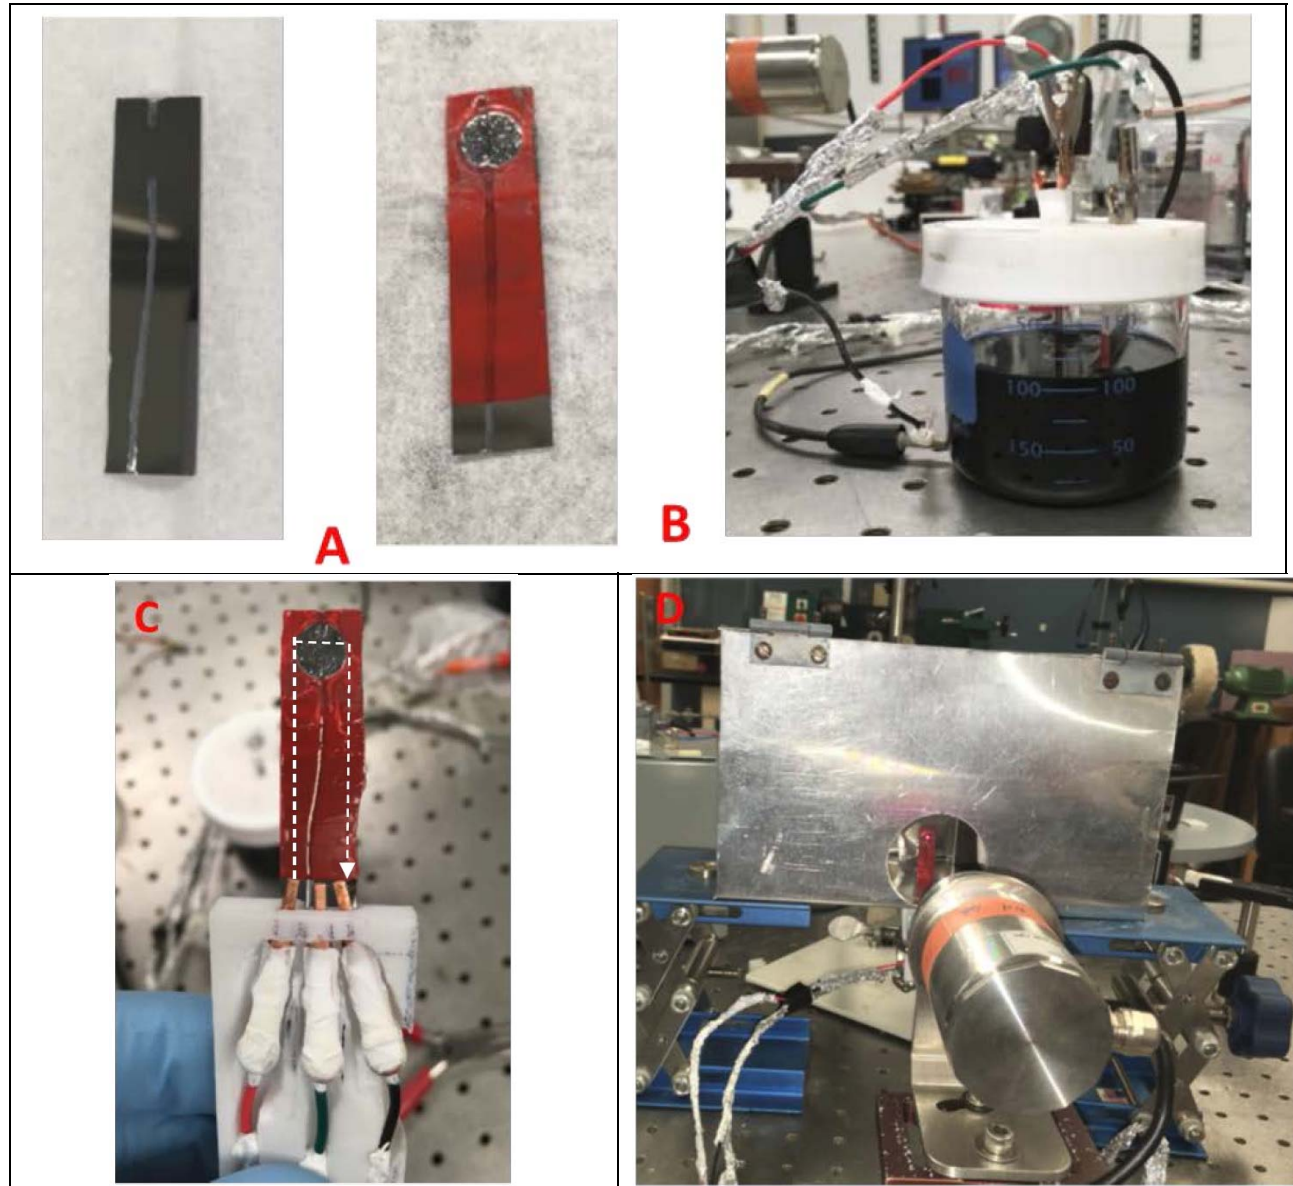
Figure 3 - The setup for *in situ* chromium thin film impedance measurements during the annealing process: (a) sample with patterned NiCr seed and sample with electrodeposited chromium film; (b) cell for electrodeposition; (c) sample holder during annealing with electrical connections. The current path is indicated with a white dotted line; (d) setup for annealing displaying enclosure, sample, laser spot targeting sampling place for temperature measurement and IR sensor.

For the purpose of these measurements, we have designed a special set up where the chromium films can be controllably heated at a desired temperature and, at the same time, their impedance can be measured *in situ*. The initial sample geometry and preparation was the same as described in previous report (Report #2; <http://short.pfonline.com/NASF16Dec2>) for room temperature *in situ* measurements (in solution and air). The samples with NiCr seeds (100 nm) on SiO₂ substrates were prepared in such a way that the conduction path in the sample was designed to go through the electrodeposited chromium film, Fig. 3(a-c). The electrodeposition set up, as in the previous measurements, was designed to match the electrode areas and separation used in the cell for *in situ* stress measurements, Fig. 3c. Each sample was electrodeposited just prior to the measurement to reach the thickness of ~ 15 microns. The chromium films were heated using a tandem of two IR heaters positioned at the back of the film, while the temperature of the film surface was measured by an IR-sensor positioned on the front side, Fig. 3d. The chromium film-fixture and the heaters were enclosed in a radiation-reflective box to minimize the heat losses to the environment. The film surface was optically accessible through the opening in the enclosure from the front side to the laser targeting mechanism of the IR sensor's optics. This allowed precise positioning of the area/spot of the chromium film from which temperature was measured, Fig. 3(c-d). The representative temperature transient during chromium thin film annealing is shown in Fig. 4. One can see that the 250°C temperature is reached within the first 150-200 sec, and for the rest of the annealing time (3 hr), it was kept constant.

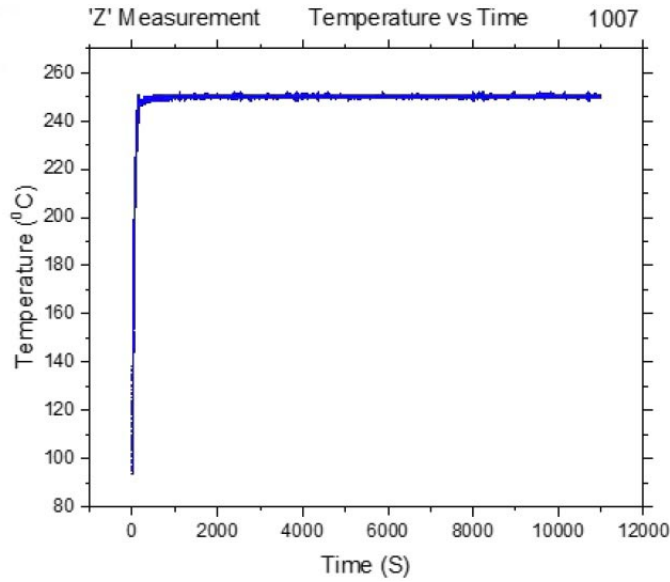
Figure 4 - Representative temperature transient during chromium thin film annealing.

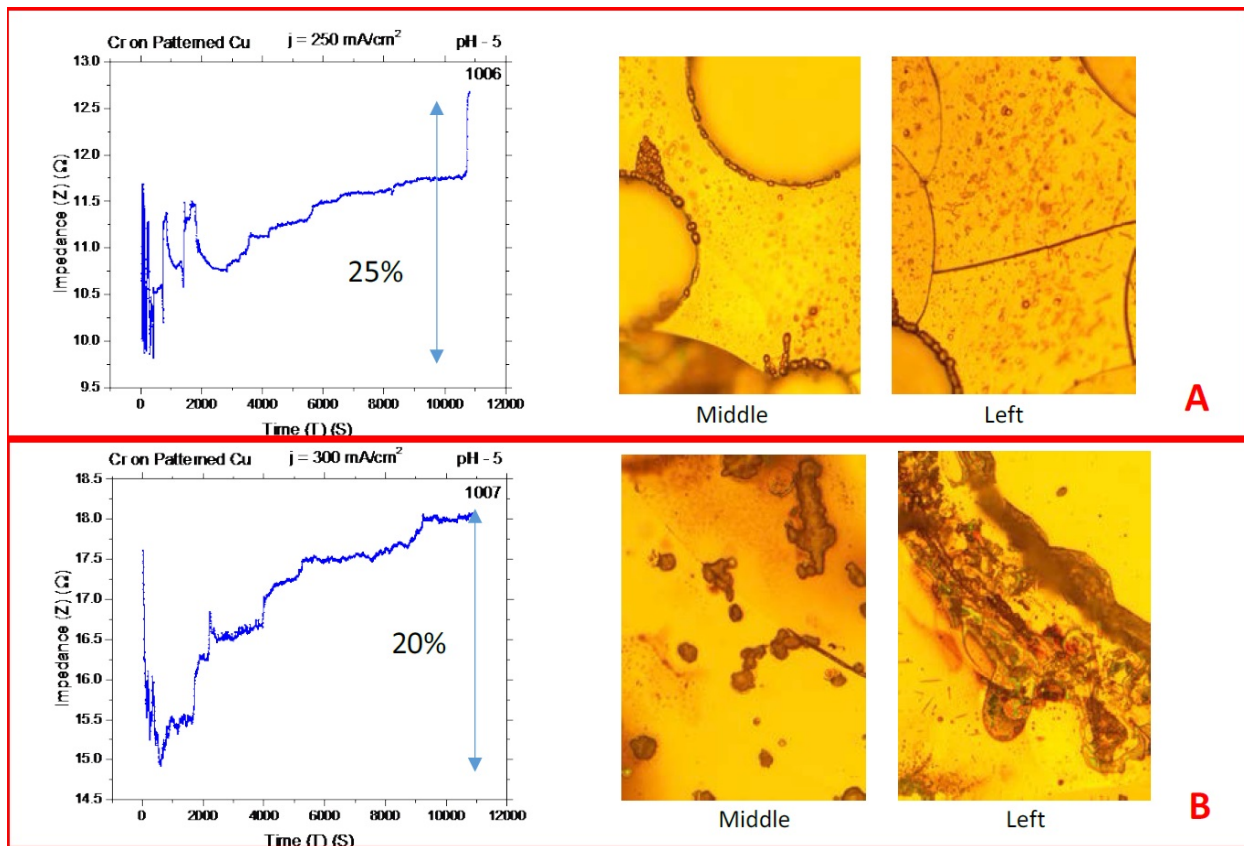
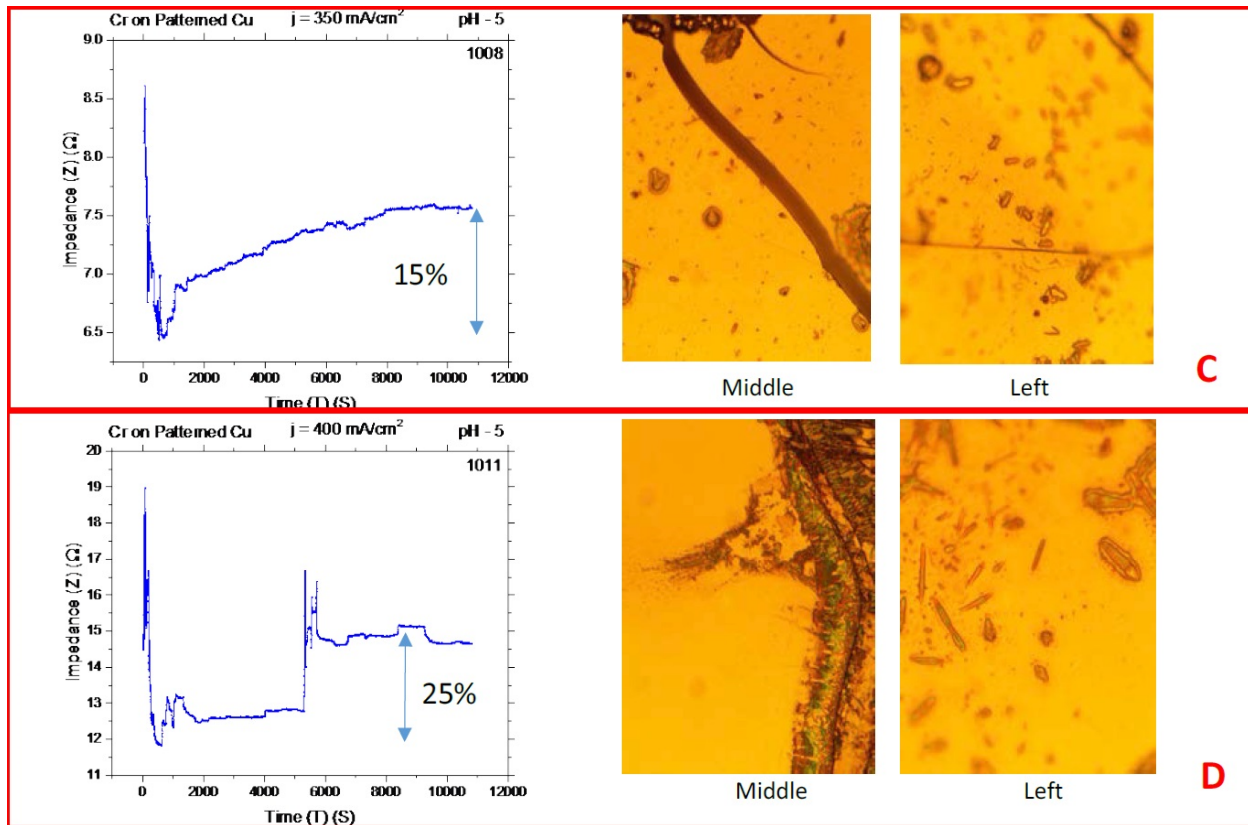
Figure 5 - *In situ* impedance measurements of chromium films during aging at 250°C in air. The chromium films were deposited for 3 hr at current densities of (a) 250 mA/cm², (b) 300 mA/cm², (c) 350 mA/cm² and (d) 400 mA/cm². Optical images are taken from the center and very near edge of the sample. AC amplitude = 3 mV, frequency = 50 kHz.

The results from the *in situ* impedance measurements are shown in Fig. 5(a-d), over pages 20 and 21. In all samples tested, the common feature of the impedance transients is a sharp decrease in the initial impedance value as the temperature is raised to 250°C, and then an increasing trend with the progression of the annealing run. All transients exhibit a sharp spikes and discontinuities which are the signature of crack formation in the chromium film. The relative change in the impedance value during the course of experiment is indicated in each transient. The representative optical images of the chromium surface are shown on the right side of the corresponding sample/transient. In some of the images, the presence of cracks is evident, although not of very high density. The films do show a slightly different surface morphology than the ones obtained during room temperature aging, Fig. 5 vs. Fig. 1. At this point however, a more quantitative analysis of the difference is not possible based on the optical images we have acquired.

A closer examination of the impedance transients from Fig. 5 shows that the frequency of abrupt interrupts of the transients, *i.e.*, chromium film cracking, is the largest for the samples deposited at 250 mA/cm² and 400 mA/cm² (Fig. 4a,d). The same samples do show the largest overall change in impedance. This is expected as the cracks formed do represent an ultimate obstacle for current flow. Therefore, within this experiment, the transient qualitative appearance is in agreement with the overall impedance change during annealing. The optical images of the 250 mA/cm² sample show clear evidence of crack formation while this is not obvious in the case of 400 mA/cm² sample.

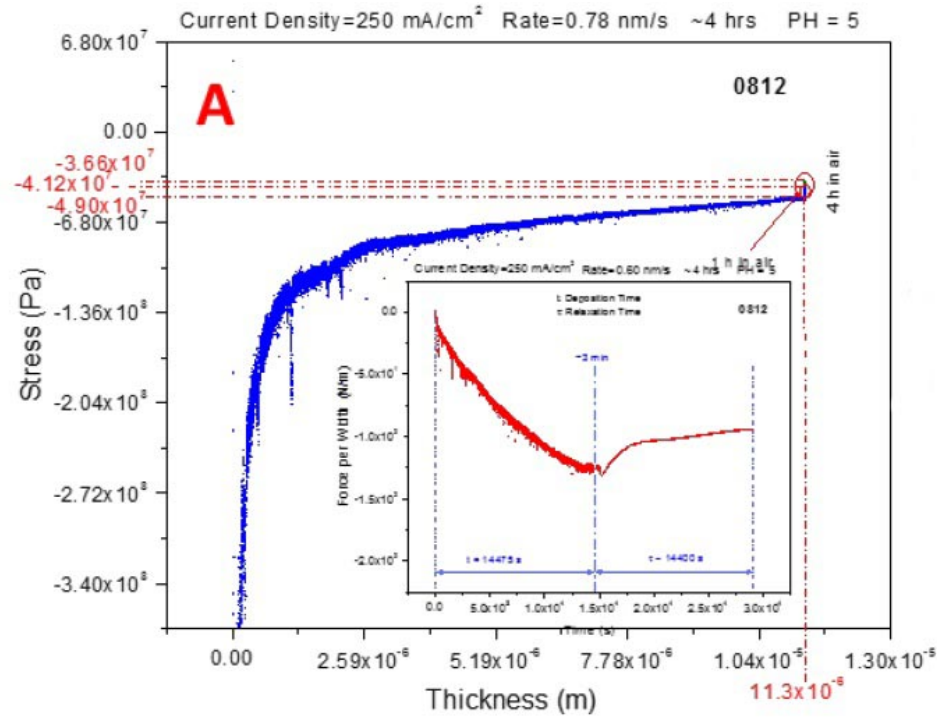
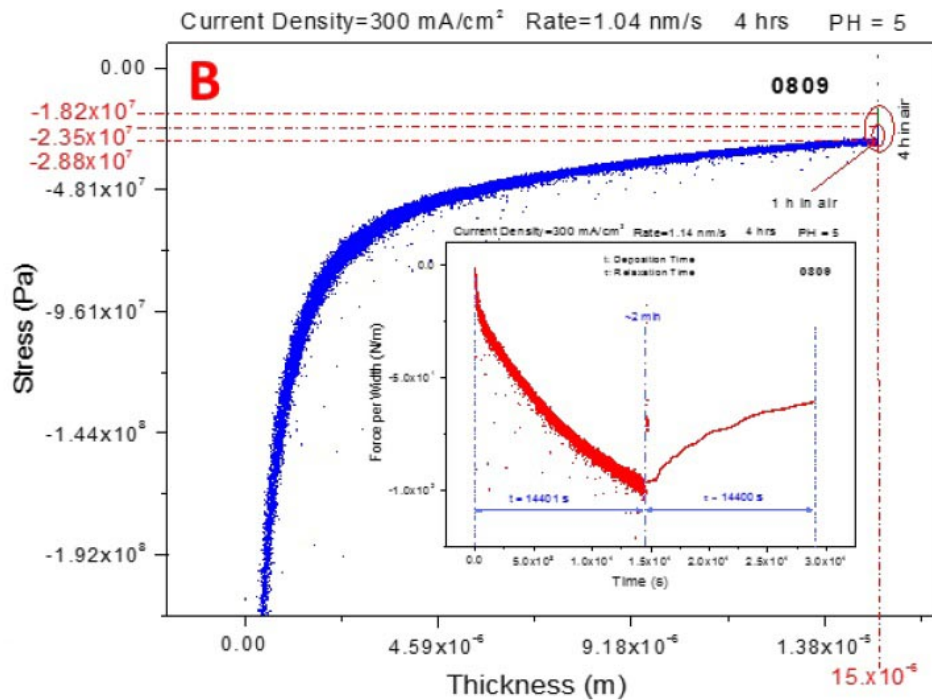
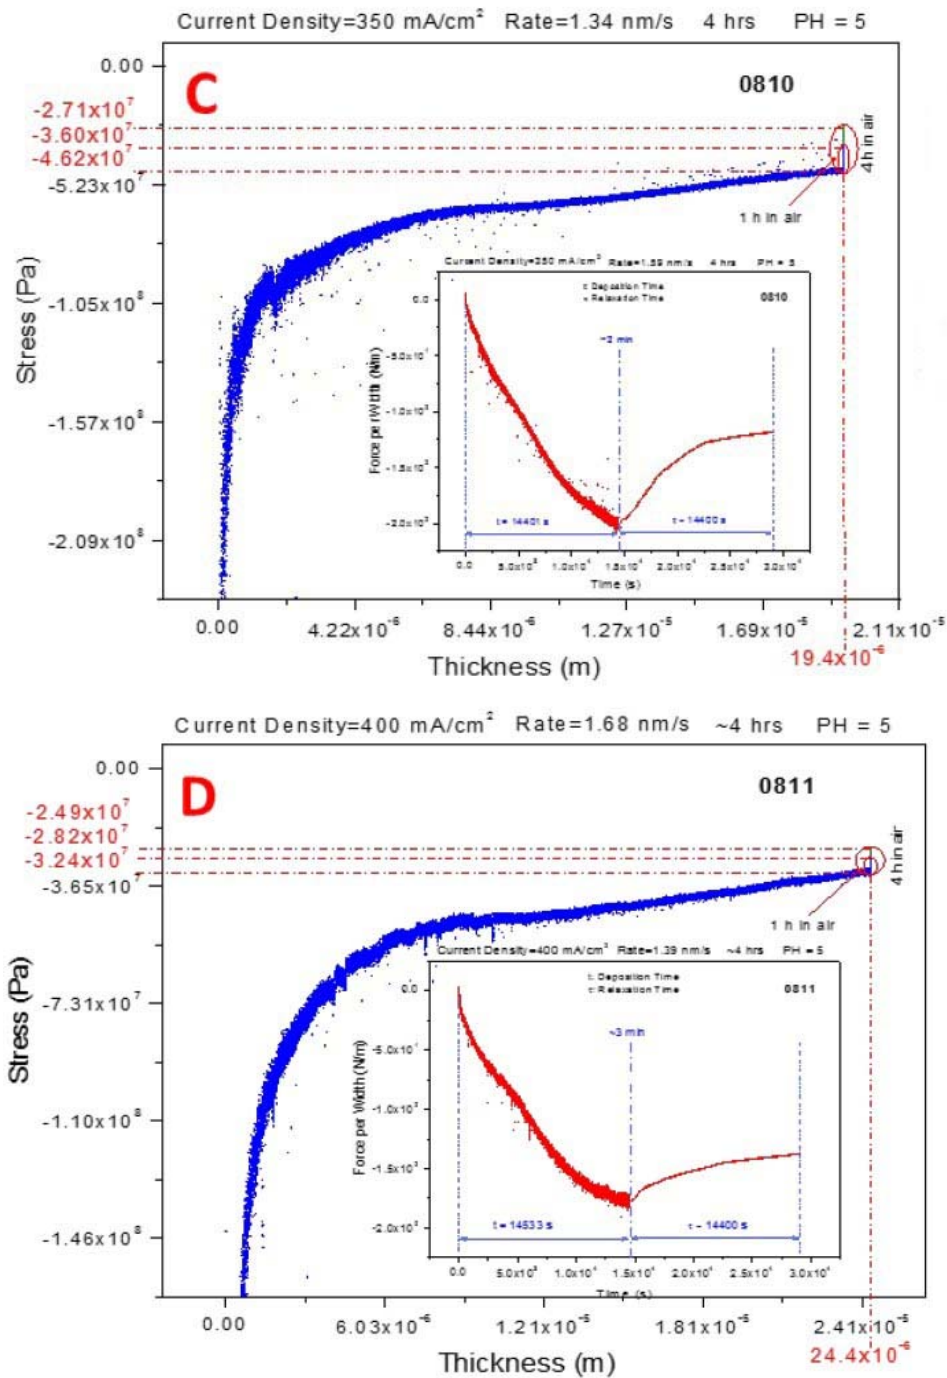
Figure 6 - *In situ* stress measurements during deposition (blue - transients, stress vs. thickness) of chromium films and during aging in air (red - transients, stress vs. time): (a) 250 mA/cm², (b) 300 mA/cm² (c) 350 mA/cm² and (d) 400 mA/cm².

Figure 6 shows the stress-thickness and stress-time curves for *in situ* measurements during deposition (250-400 mA/cm²) and subsequent aging of chromium films in air.

The three-second interruption between the deposition and aging steps of the measurements is related to the solution dispensing. The blue curves represent the stress-thickness dependence and the red curves are stress transients. The common feature of all of the measurements is that, as in the previous report, the deposition stress of the chromium films is compressive, entering a steady state mode after approximately 1.5 hr of deposition, Fig. 6(a-d) over pages 23 and 24.

The aging stress relaxation is tensile for each sample entering the steady state after approximately 2 hr. This behavior is very similar to what we have reported previously for the stress evolution studies of chromium films during aging in solution. The tensile stress relaxation as a function of current density used for chromium deposition has a weak decreasing trend. The magnitude of tensile stress relaxation is on the order of several tens of MPa, which is a relatively low change of stress at the end of deposition step, Fig. 6(a-d). The stress transients (red lines in Fig. 6) during deposition and aging do not show any abrupt change indicating no crack formation. This result is in perfect agreement with the qualitative shape of the *in situ* impedance curves shown in Fig. 1. Therefore, both *in situ* measurements, impedance and stress, suggest that there is no crack formation during room temperature aging of chromium films in air. This conclusion is the same as the one from our previous report where aging of chromium films in solution was studied.

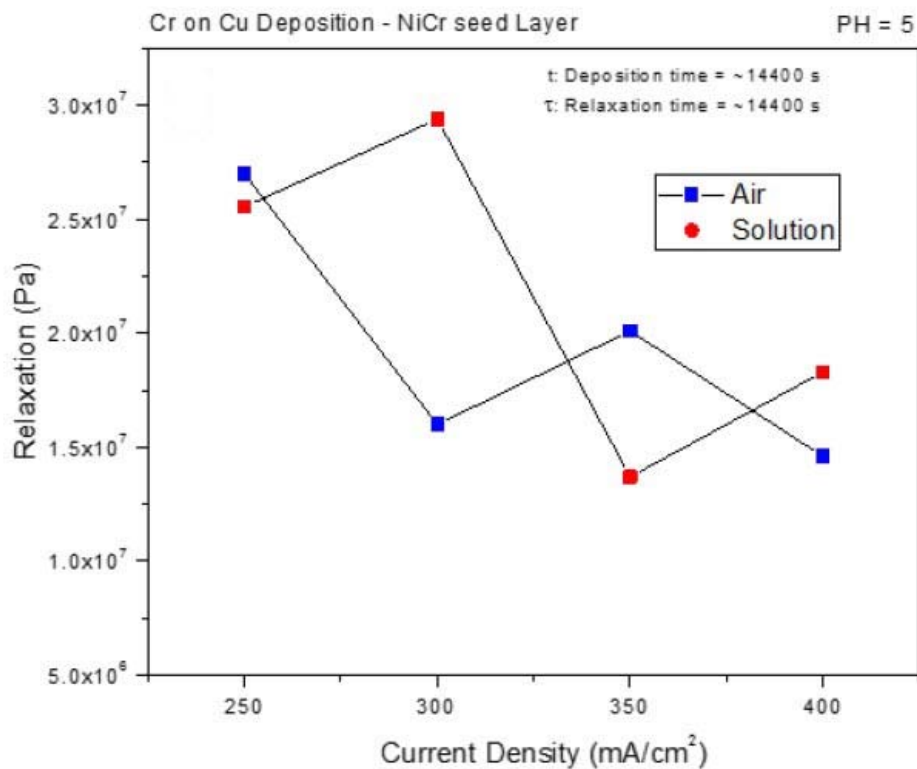
Figure 7 - The maximum tensile relaxation of chromium films during a three-hour aging in solution (red - previous report) and air (blue - data from Fig. 6).

Comparison between stress relaxation data for chromium films aging in air and for chromium films aging in formate solution is shown in Fig. 7. Both sets of experiments yield qualitatively the same trend and the same magnitude of the stress change. To some extent this is expected, knowing that relatively more Cr-hydride per deposited chromium atom should be formed at a lower current density where the current efficiency is lower (see previous report). Assuming that Cr-hydride decomposition is the main mechanism leading to the tensile stress relaxation, we expect larger tensile relaxation for the samples deposited at lower current densities. Therefore, the agreement between stress relaxation data in these two sets of experiments shown in Fig. 7 is not surprising.

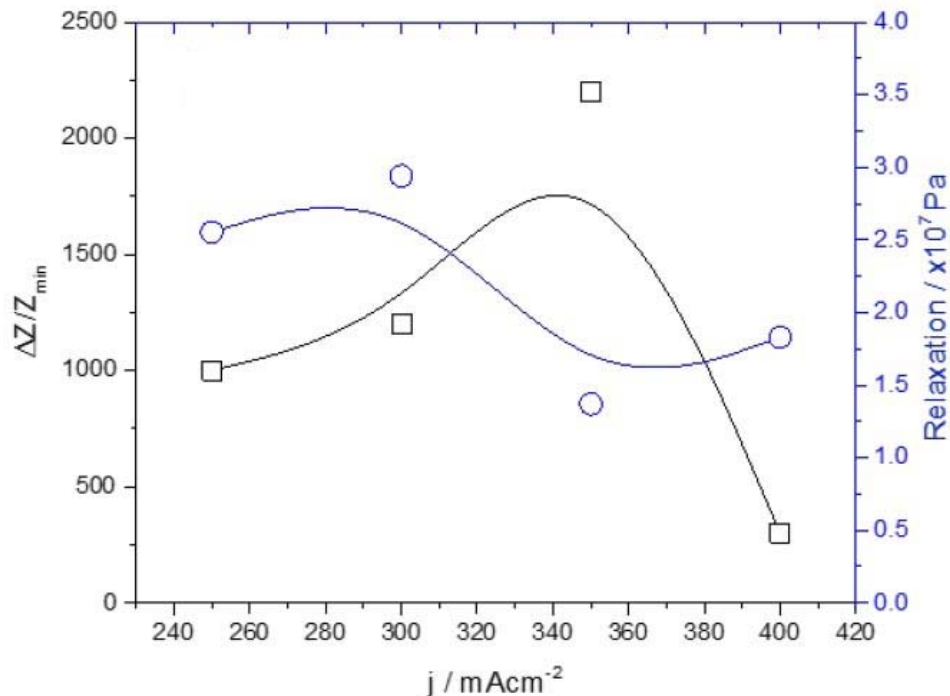
Figure 8 - Summary of the data from Fig. 1 (black lines) and Fig. 6 (blue lines).

First, the tensile stress relaxation and change in impedance do not follow the same trend as a function of current density. They completely diverge, shown in Fig. 8. This is significantly different from what we have observed during the aging of chromium films in solution. In this case, the stress and impedance data agreed very well, expressing a decreasing trend (Report #2, Figs. 4 and 6).
